UNITED STATES AIR FORCE
AIRCRAFT ACCIDENT INVESTIGATION
BOARD REPORT

B-52H, T/N 60-0047
69TH EXPEDITIONARY BOMB SQUADRON
5TH BOMB WING
ANDERSEN AIR FORCE BASE, GUAM

**LOCATION: DEPARTURE END OF RUNWAY 06L, ANDERSEN AIR FORCE BASE,
GUAM**

DATE OF ACCIDENT: 19 MAY 2016

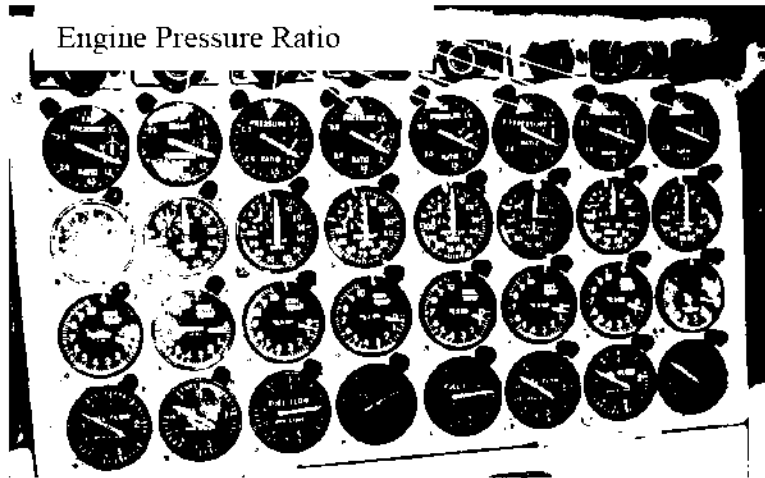
Figure 5. Engine Stack

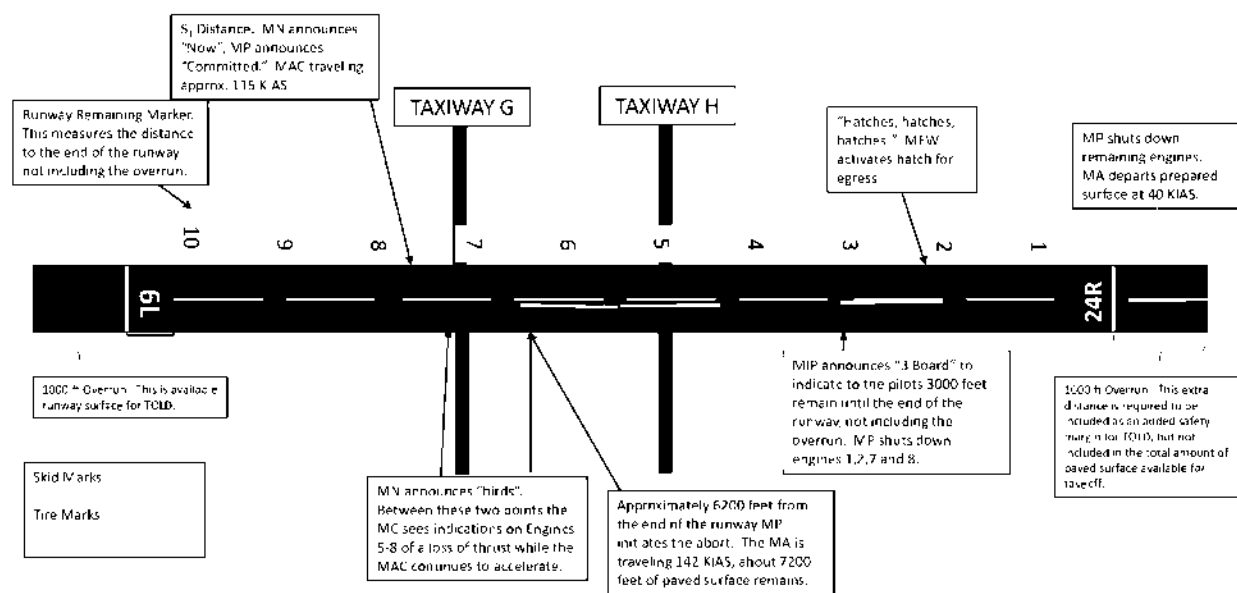
Figure 6: Mishap Sequence of Events

Referring to Figure 6, the skid marks followed by the tire marks on the runway are consistent with proper anti-skid system operations. Additionally, the lack of tire marks from approximately 2,000 feet remaining until the end of the runway suggests the brakes absorbed the maximum prescribed energy during the abort and were no longer effective (Figure 6). All brakes show signs of heat stress and fire (Figure 9).

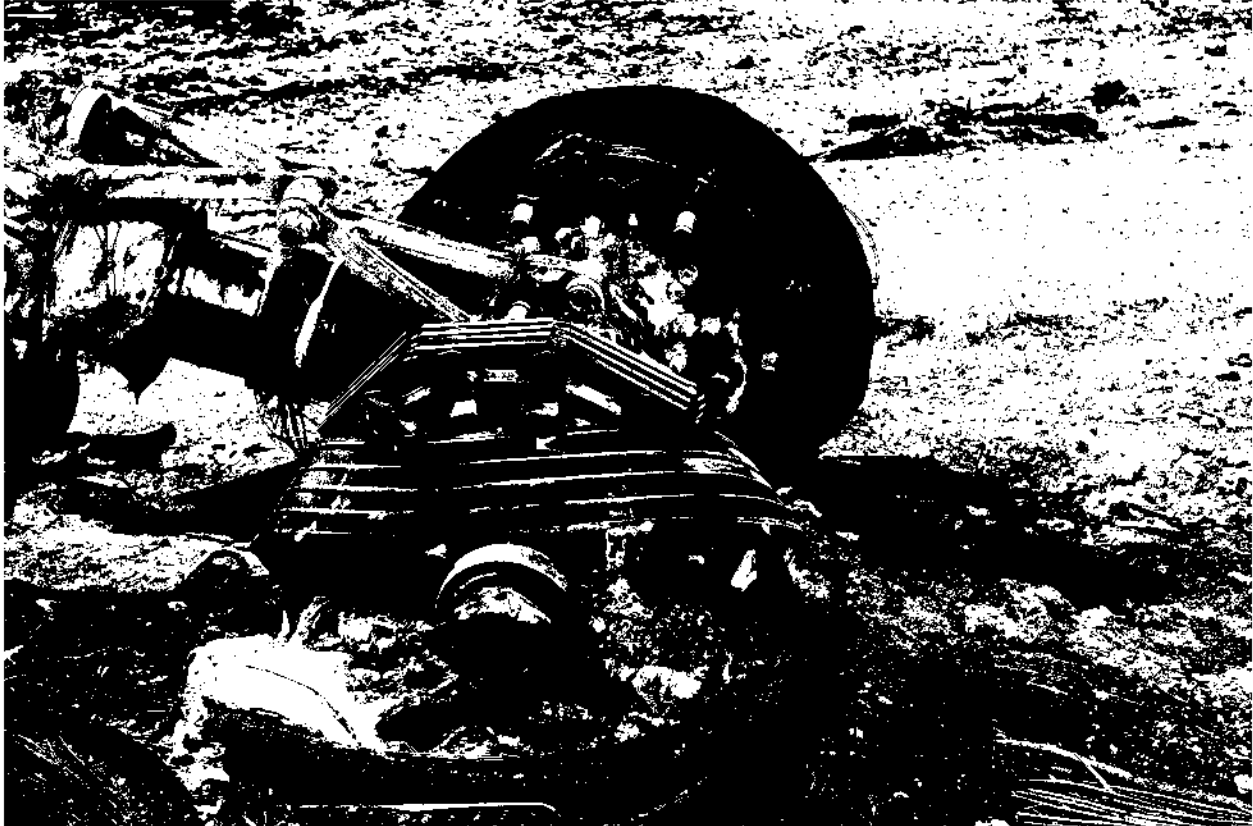
Using charts provided in T.O. 1-B-52H-1-1, the braking energy absorbed by the MA can be calculated. By applying the aircraft gross weight, airspeed at brake application, pressure altitude, and runway temperature, the braking energy calculated on the MA exceeds the capabilities of the supplied chart. Interpolating "off the chart," a value of approximately 335 million foot-pounds can be estimated, above the maximum limit of brake failure (Tab BB-15). If the drag chute worked as designed, a value of 295 million foot-pounds can be estimated, providing some validation of the simulator crew's ability to stop before the end of the runway surface when the drag chute was effective (Tabs BB-15 and EE-3).

Figure 9. Brakes and tires showing evidence of overheating and fire

The B-52H brake-energy limit is 298 million foot-pounds total for all eight brakes. This is the maximum energy the brakes can absorb before becoming ineffective and is the stopping capability limit. Above 230 million foot-pounds accumulation, fire and tire explosion are imminent. According to technical data, the brake-energy charts are the best possible estimate to assess heat-energy absorption. Using the MA gross weight, speed at brake application without drag chute, weather conditions, and adjustments for runway slope, the MA brake-energy accumulation exceeded charted technical data of 325 million foot-pounds. Interpolation off the chart suggests upwards of 335 million foot-pounds accumulation of brake energy for the MA. Evidence of the termination of rolling skid prior to the end of the runway, the extreme brake energy absorbed under the abort conditions, and the speed at which the MA crossed the end of the runway and then the end of the prepared surface, I conclude the brake energy limits on the MA were exceeded and the MA brakes were ineffective even though the MP continued brake pressure throughout the entire abort. Because the MA exceeded the stopping capability limits of its brakes with runway remaining, and still moving at approximately 40 kts airspeed, the MA departed the prepared surface. This resultant failure substantially contributed to the MP's inability to stop the MA within the confines of the runway.
