**UNITED STATES AIR FORCE**  
**ACCIDENT INVESTIGATION REPORT**

**COMP AIR 7SL, AIRCRAFT NUMBER 2245**

**3rd SQUADRON, IRAQ AIR FORCE**  
**KIRKUK REGIONAL AIR BASE, IRAQ**

**LOCATION: NEAR JALULAH, IRAQ**  
**DATE OF ACCIDENT: 30 MAY 2005**

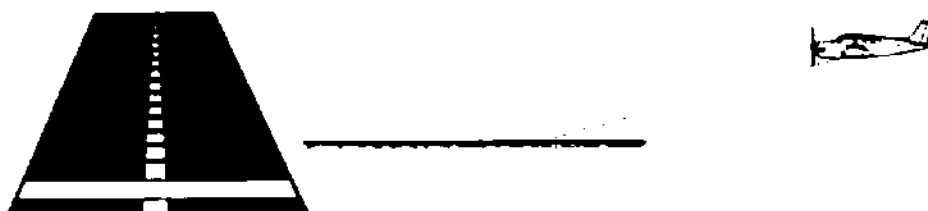
(1) Aerial Perspective Illusions may make you change (increase or decrease) the slope of your final approach. They are caused by runways with different widths, upsloping or downsloping runways, and upsloping or downsloping final approach terrain. Pilots learn to recognize a normal final approach by developing and recalling a mental image of the expected relationship between the length and the width of an average runway (figure below).

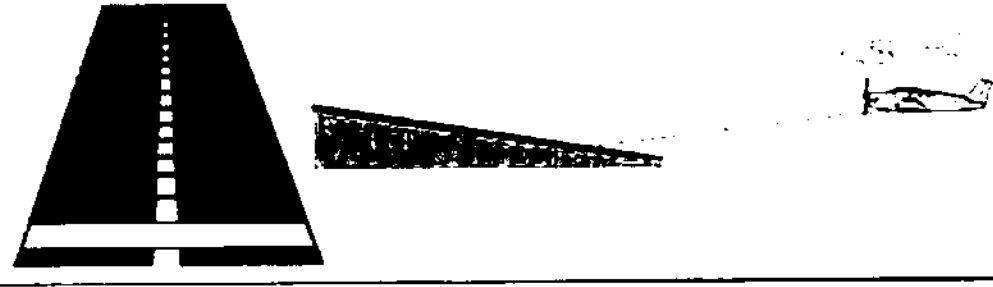
(2) A final approach over a flat terrain with an upsloping runway may produce the visual illusion of a high-altitude final approach. If you believe this illusion, you may respond by pitching the aircraft nose down to decrease the altitude, which, if performed too close to the ground, may result in an accident (figure below).

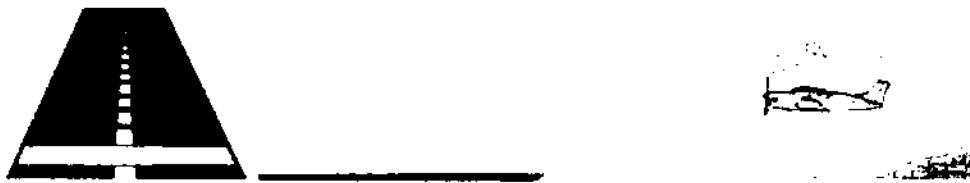
(3) A final approach to an unusually narrow runway or an unusually long runway may produce the visual illusion of a high-altitude final approach. If you believe this illusion, you may respond by pitching the aircraft nose down to decrease the altitude, which, if performed too close to the ground may result in an accident (figure below).

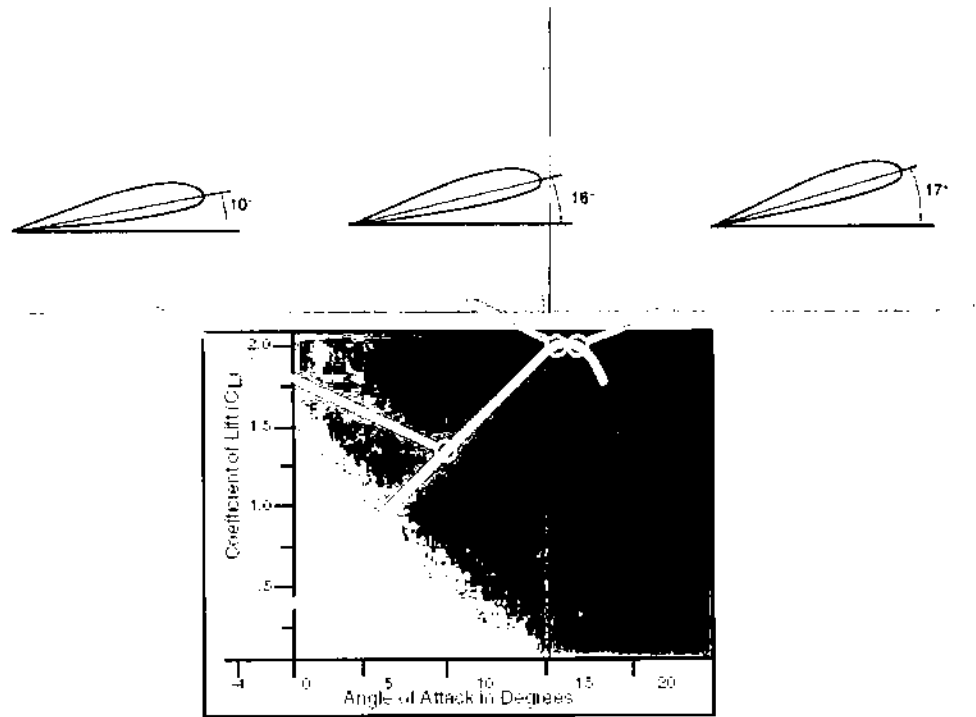
Figure 4-2. Critical angle of attack and stall.

A stall occurs when the smooth airflow over the airplane's wing is disrupted, and the lift degenerates rapidly. This is caused when the wing exceeds its critical angle of attack. This can occur at any airspeed, in any attitude, with any power setting. [Figure 4-2] The practice of stall recovery and the development of awareness of stalls are of primary importance in pilot training. The objectives in performing intentional stalls are to familiarize the pilot with the conditions that produce stalls, to assist in recognizing an approaching stall, and to develop the habit of taking prompt preventive or corrective action. Intentional stalls should be performed at an altitude that will provide adequate height above the ground for recovery and return to normal level flight. Though it depends on the degree to which a stall has progressed, most stalls require some loss of altitude during recovery. The longer it takes to recognize the approaching stall, the more complete the stall is likely to become, and the greater the loss of altitude to be expected.
